COMPASS
COMMUNITY PLANNING ASSOCIATION
of Southwest Idaho

2020 Data Bike Pilot Report

May 2021

Report No. 07-2021

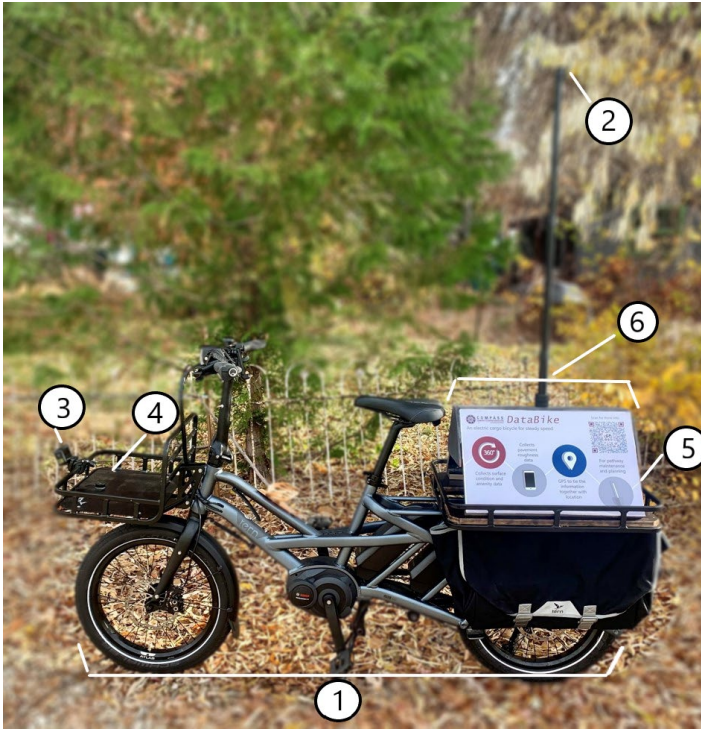
Figure 1. COMPASS Data Bike

The COMPASS Data Bike includes multiple pieces of equipment that work in tandem to collect roughness and other data as the bike is ridden (Figure 1).

1. Tern GSD Electric Cargo Bike
 - The electric-motor component of the bike is critical in order to keep the bike as close to a vertical orientation as possible, which is vital in the roughness app's measurement process. It is also outfitted with panniers for hauling gear.
2. Samsung 360° Camera
 - Used to photograph the surrounding environment; in the future, these photos will be imported to Google Maps.
3. Go Pro Hero 7 Camera
 - Used to photograph the pavement immediately below the bike. Photos can be compared to the measured roughness.
4. iPhone 7
 - Used to host the rRuf roughness measurement app (Figure 2).
5. Power Bank
 - Used as external power source for cameras and the iPhone in the field. This component isn't used for each deployment, but can be relied upon for longer deployments that could deplete battery levels.
6. Canopy
 - Used to stabilize the 360° camera.

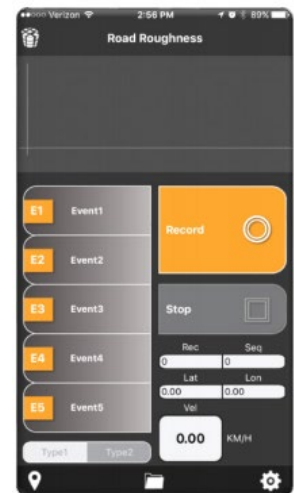
Figure 2. rRuf roughness measurement app

The rRuf app scores the condition of trails by using the iPhone's internal accelerometer and gyroscope to produce a standardized condition rating. The app includes an automated intelligent map that matches the data to the trail segment. Through a dashboard on the app, data collection can be monitored to identify gaps. The app is also able to produce averages and other statistics if a section of the trail is ridden multiple times. This helps alleviate any minor inconsistencies in the roughness data.

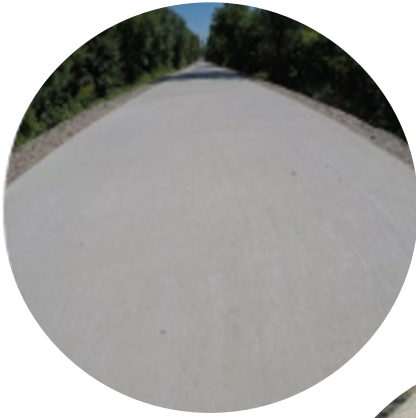
Very Smooth

Very smooth trails have nearly no cracking or vegetation growing on them. Variations in smoothness can be due to seams between concrete sections or other material spread across the trail.

The bike measures trail roughness using the iPhone's accelerometer data, which indicate significant changes in roughness of trail segments. Using this data, the trails are then categorized into five roughness categories, ranging from "very smooth" to "very rough" (Figure 3).

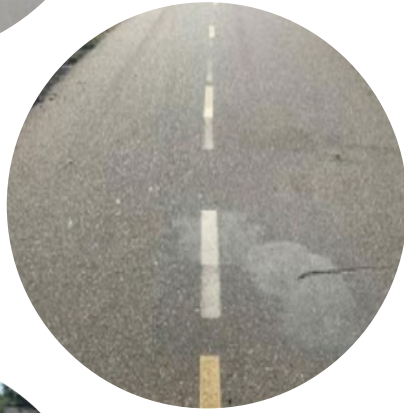
Smooth trails are typically in good condition, but are beginning to show signs of cracking. Cracking on smooth trails generally does not create discomfort for the rider.

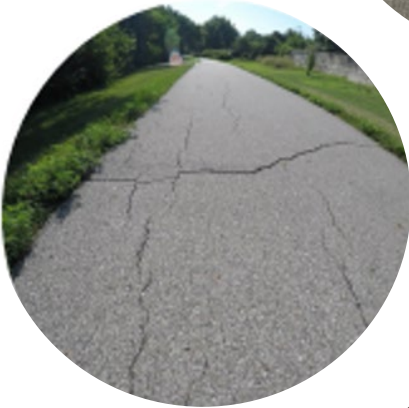
Fair trails are beginning to show increased wear and typically have more cracking. Cracking on trails in fair condition can cause minor discomfort for riders.

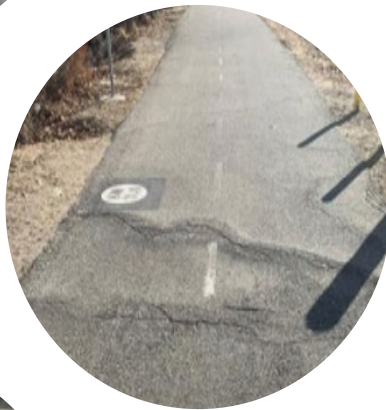
Rough trails show minor buckling or advanced cracking, with vegetation growing through the surface. These cracks are typically wider and deeper than cracks along fair condition trails and can cause discomfort for riders.

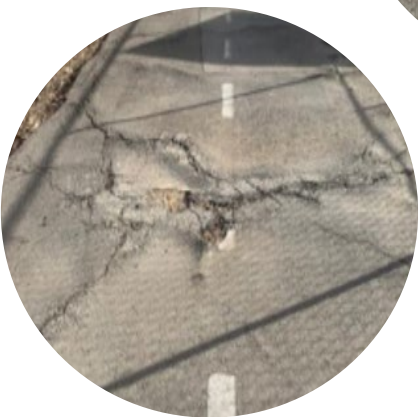
Very Rough

Very rough trails have cracking similar to trails in rough condition, but also have buckling of the trail surface. Very rough conditions on trails, if traversed, can cause discomfort for riders.
